S T A T I O N S O F T H E C R O S S
Our Lady of Montserrat Church, Parish of Tortuga, Trinidad

A REPORT BY SUSAN M MOORE BSc,

RESTORATION REPORT

Our Lady of Montserrat Catholic Church, Tortuga

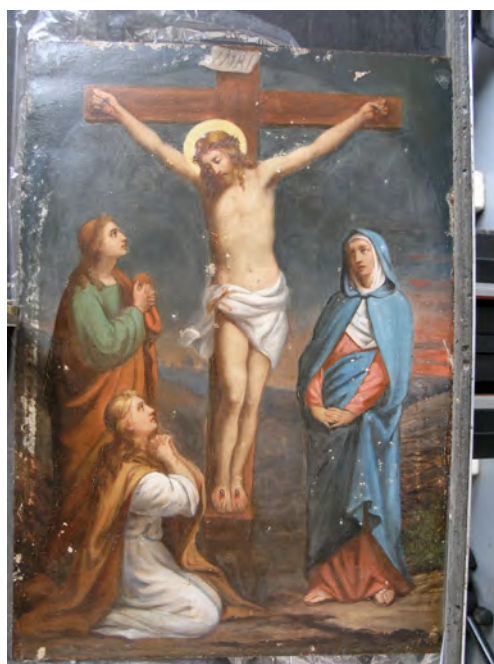
These are obviously not the original or intended frames as they often obscure details, for example most of the legend nailed to the top of the cross and much of the hands of Christ (see Fig 1, below).

Fig 1 The darkened area at the top of the picture clearly shows the extent of the arched frame

The area under the frame has also suffered due to the ingress of dust and moisture.

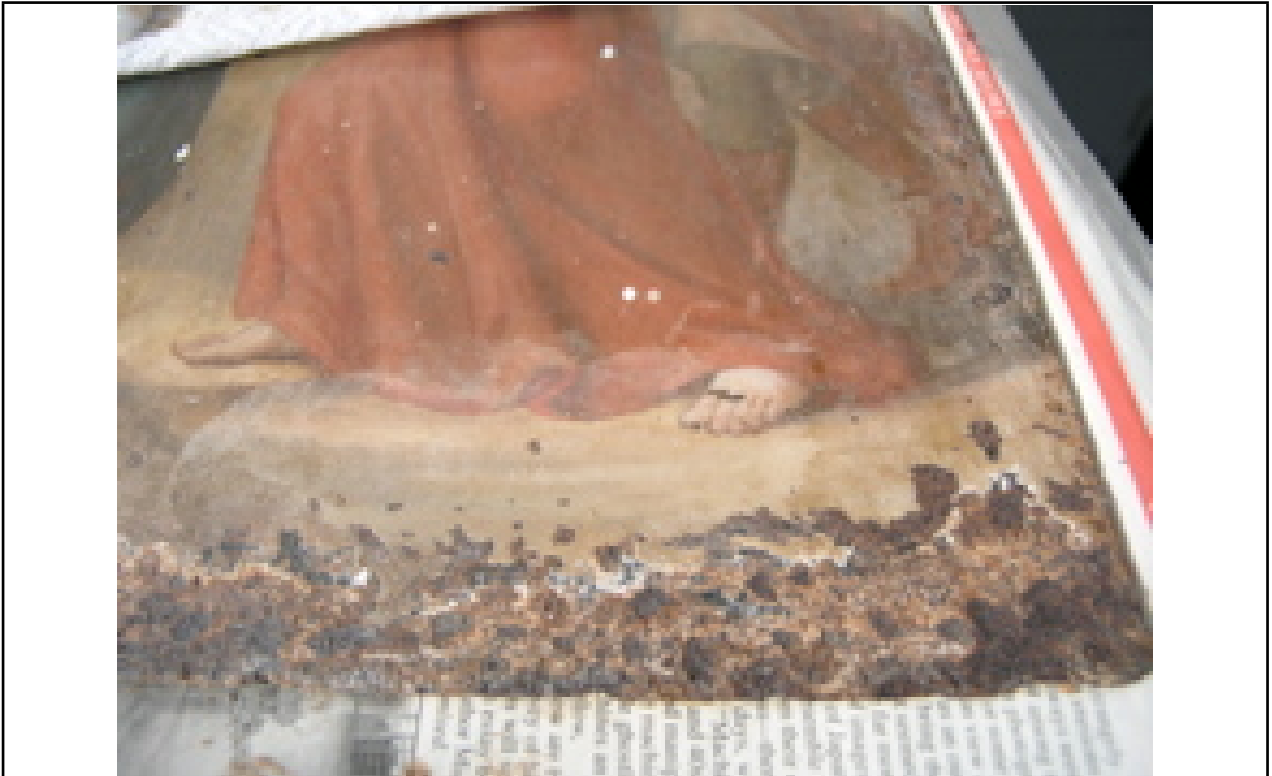
In fact, very little of the paint surface had detached, apart from areas of obvious damage caused primarily by the effects of corrosion (See Fig 2, below). Iron oxides formed in a moist environment (rust) swell on creation, distorting the surface of the material and causing any surface coating to detach.

Fig 2 Showing rusting and subsequent paint loss.

Where this had occurred, the paint surface sadly proved unrecoverable. On the positive side, most of these areas were confined to edges or corners with little detail apparent. Their repair, then, was easier than hoped.

In some small areas, the edges of the paint surface around areas of loss were loose. These were consolidated with **BEVA**, heat sealed, then swabbed with dilute dichloromethane cleared with IMS to remove traces of excess.

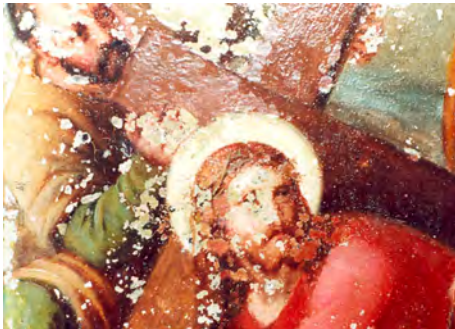
After cleaning, showing paint losses

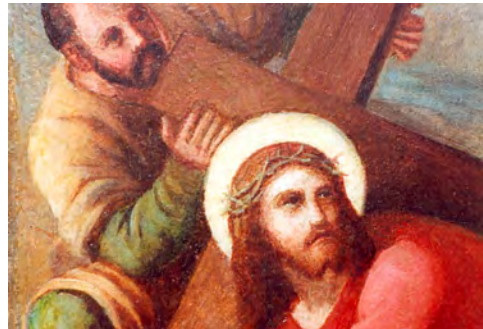
After restoration, showing reconstruction

A further coat of **B72** was then applied. Paint losses were repaired. Where required, some features were reconstructed, e.g.

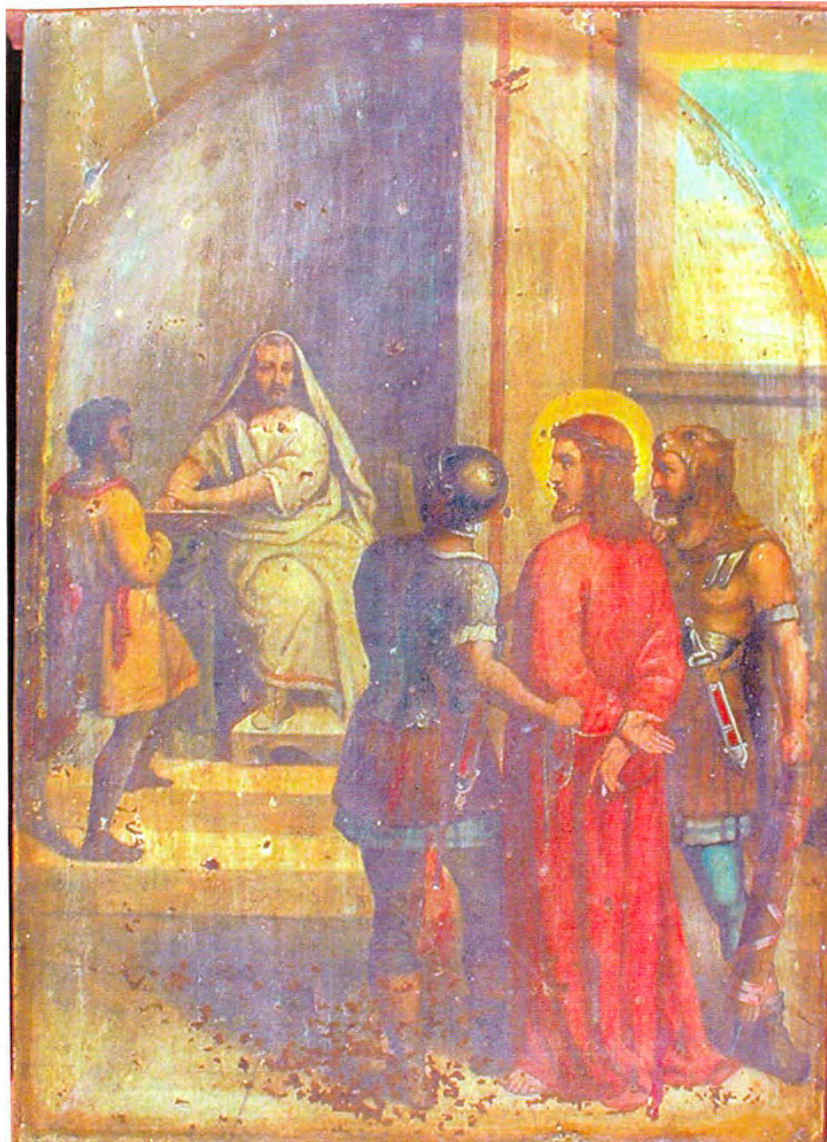
Station No:I - Jesus is condemned to death

Badly rusted

Varnish discolouration, with significant paint loss at the bottom centre. Further paint loss due to pitting over much of the rest of the surface. Several chips in paint surface. Edges sound - no significant flaking, bubbling or chipping.

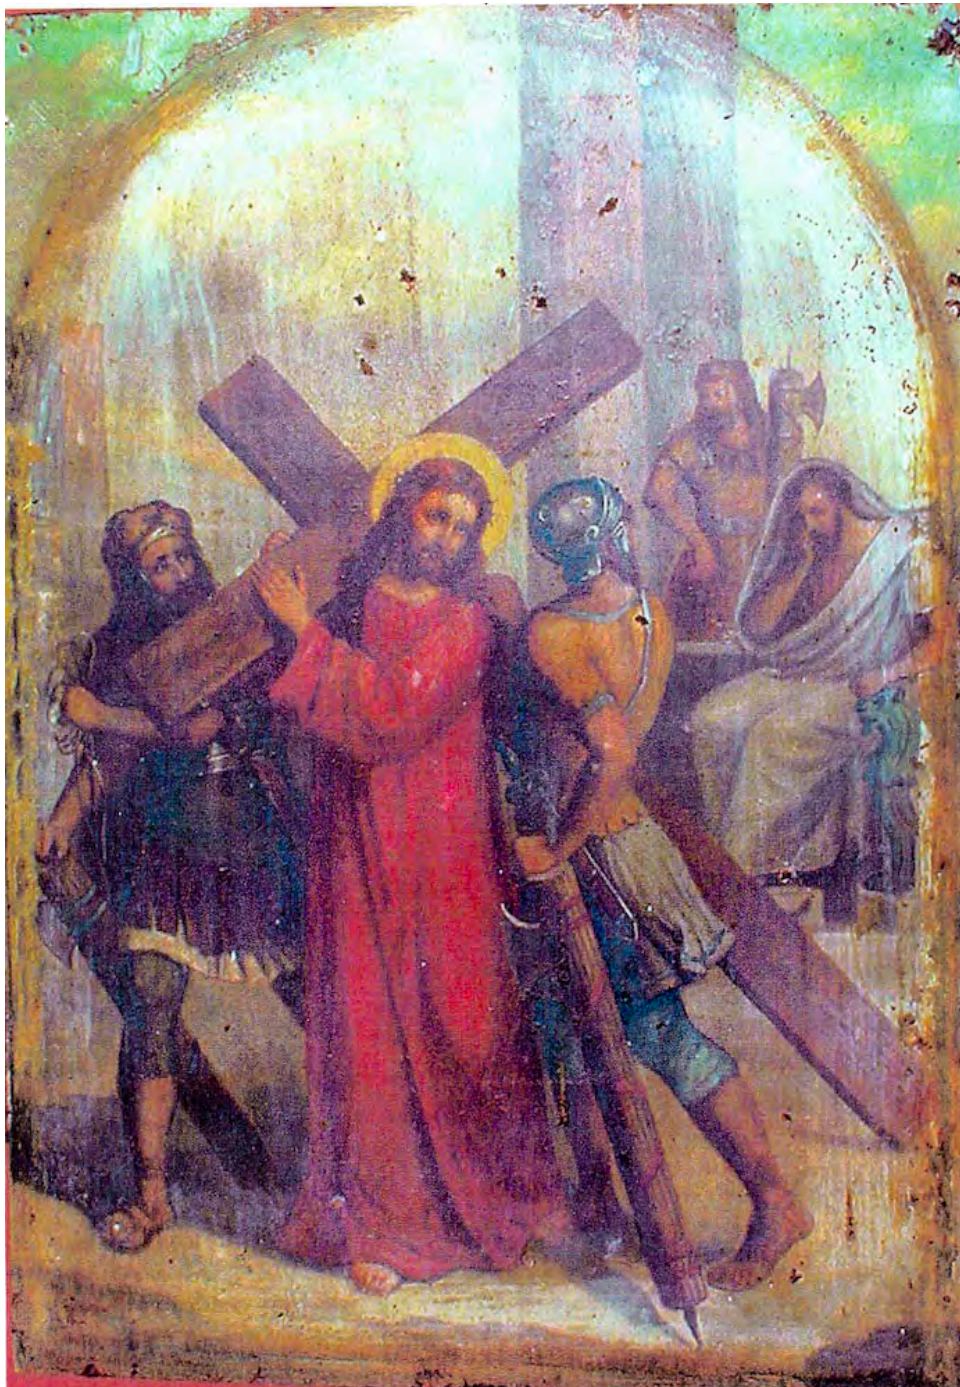
Station No:II - Jesus receives the cross

Corrosion of edges and some evident on front surface.

Discolouration of varnish. Paint loss on right hand edge with a significant loss at the top right corner. Large pits and paint loss, mostly towards the top of the picture.

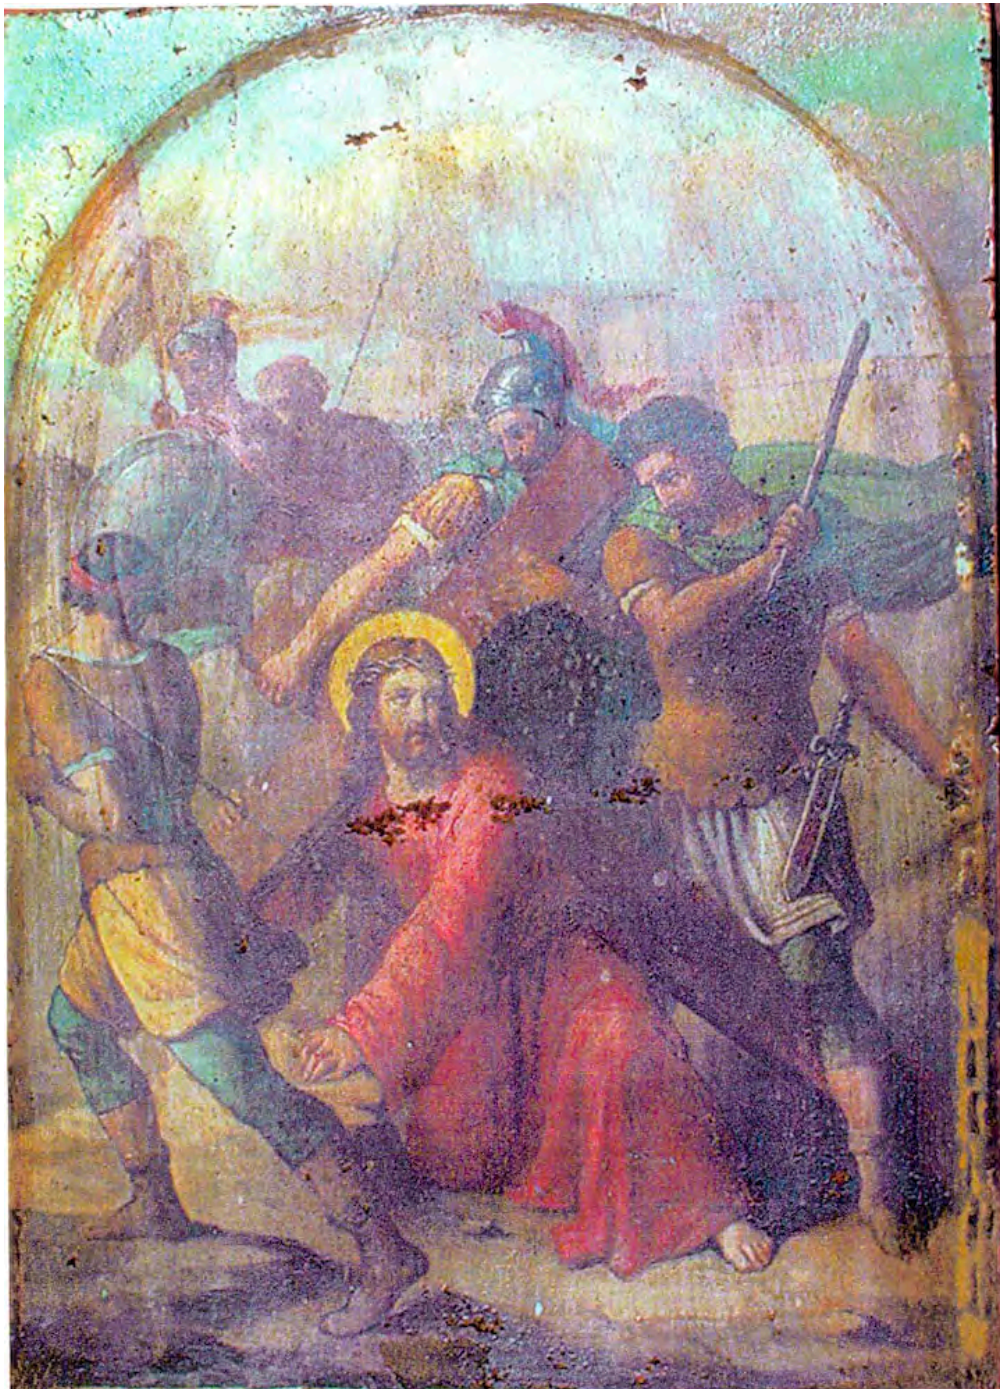
Station No:III - Jesus falls the first time

Overall good condition, with some minor edge damage.

Varnish discoloured and becoming opaque. Significant paint loss in centre, bottom left corner, with pitting near the top edge. Right edge chipped and corroded.

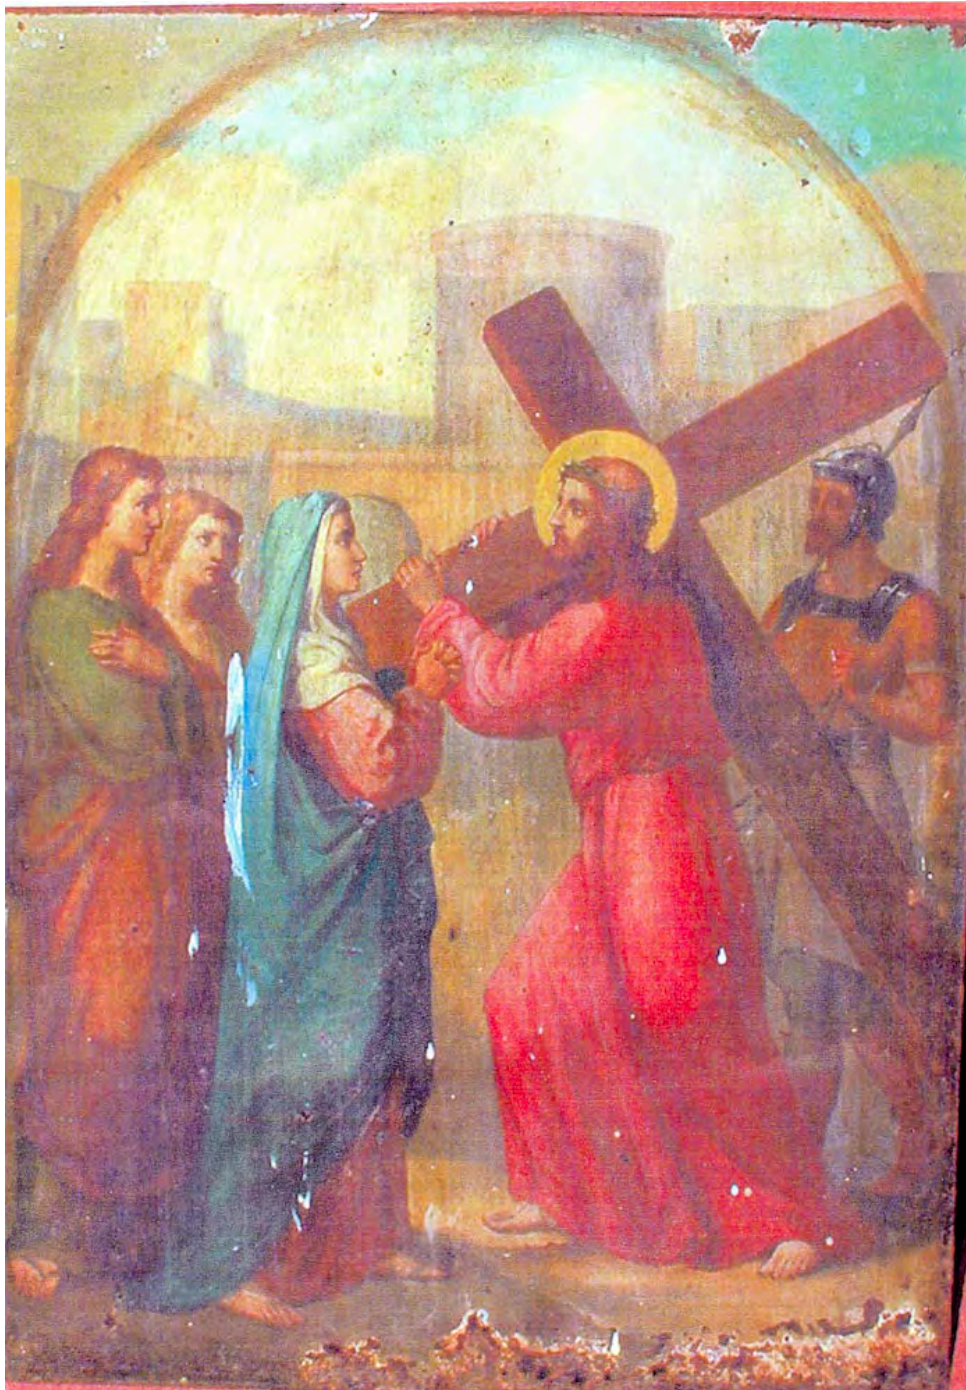
Station No:IV - Jesus meets His Mother

Bottom edge severely corroded, with smaller areas of corrosion visible on top right hand corner.

Varnish discoloured and streaked. Varnish also becoming opaque. Major paint loss along bottom edge with some additional surface damage. Chips in top edge towards right. Paint faded in centre top.

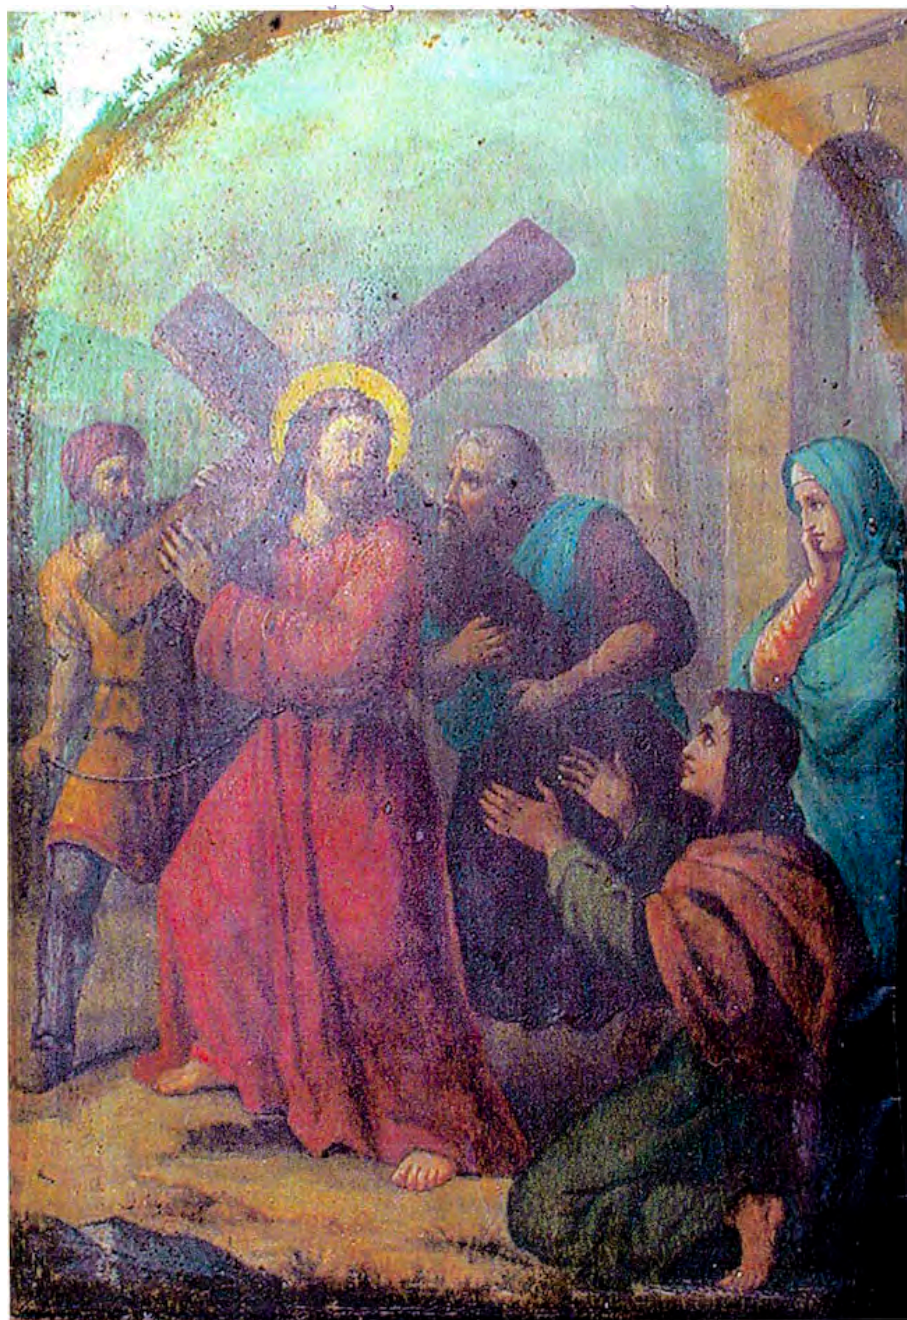
Station No:V - Simon of Cyrene carries the cross

Good general condition, but with minor damage to right and left edges.

Varnish becoming opaque. General pitting of surface, with “orange peel” effect over the face of Jesus and the top of the cross. Crazeing of surface in centre. Paint losses at top left corner.

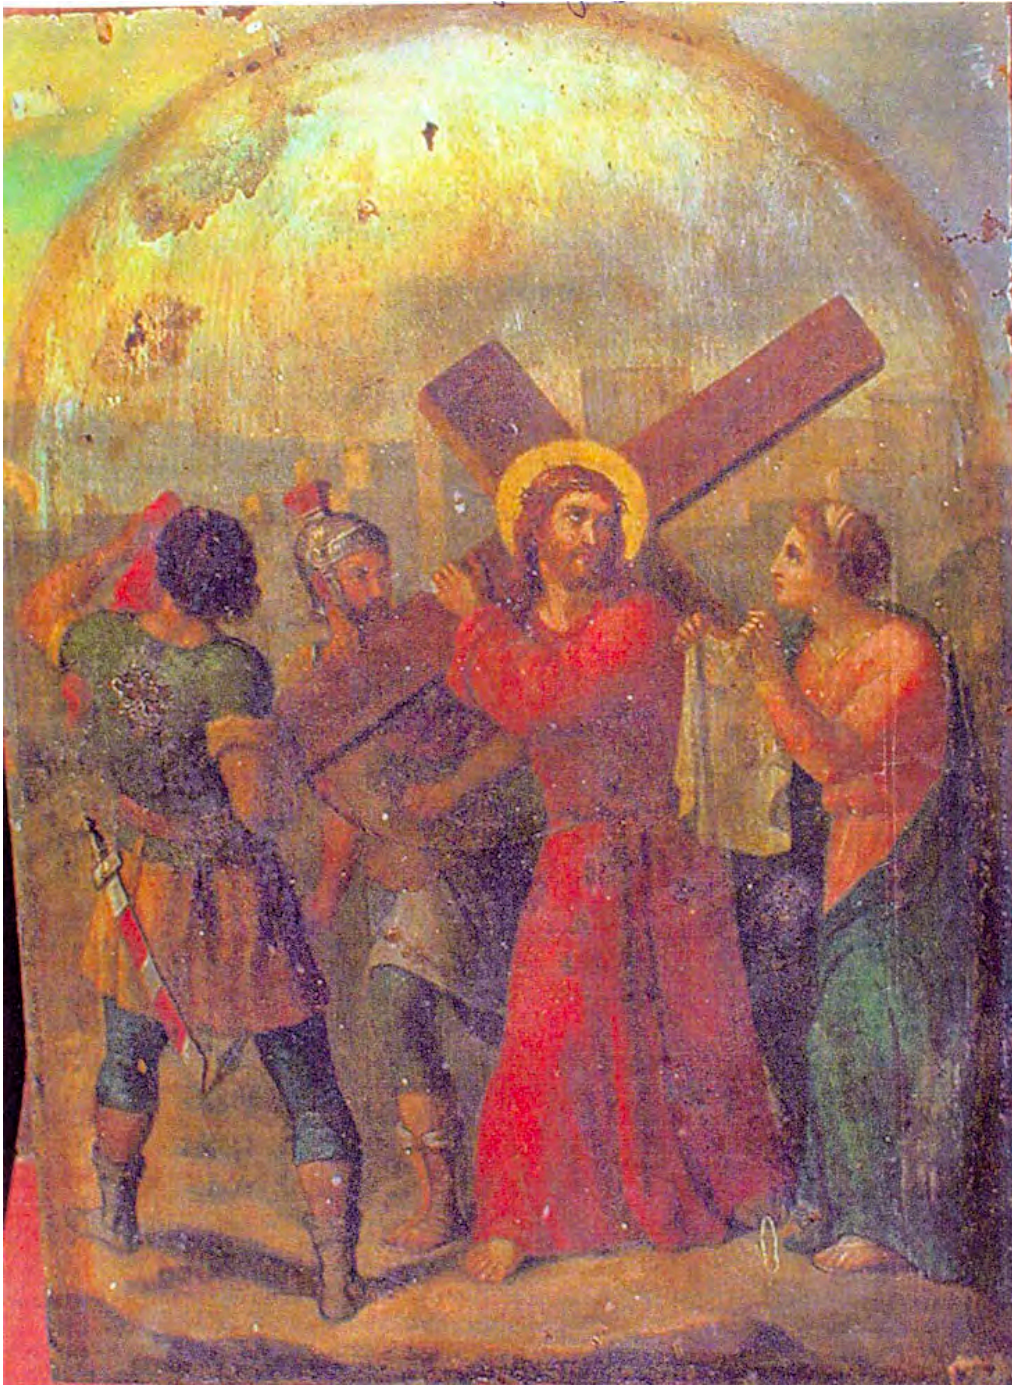
Station No:VI Veronica wipes the face of Jesus

Generally in good condition, but with six or seven major pits, and erosion of bottom edge.

Badly discoloured varnish layer with some paint loss, particularly on bottom right corner and in the centre towards the left hand edge. Severe discolouration towards top left corner. Right edge chipped.

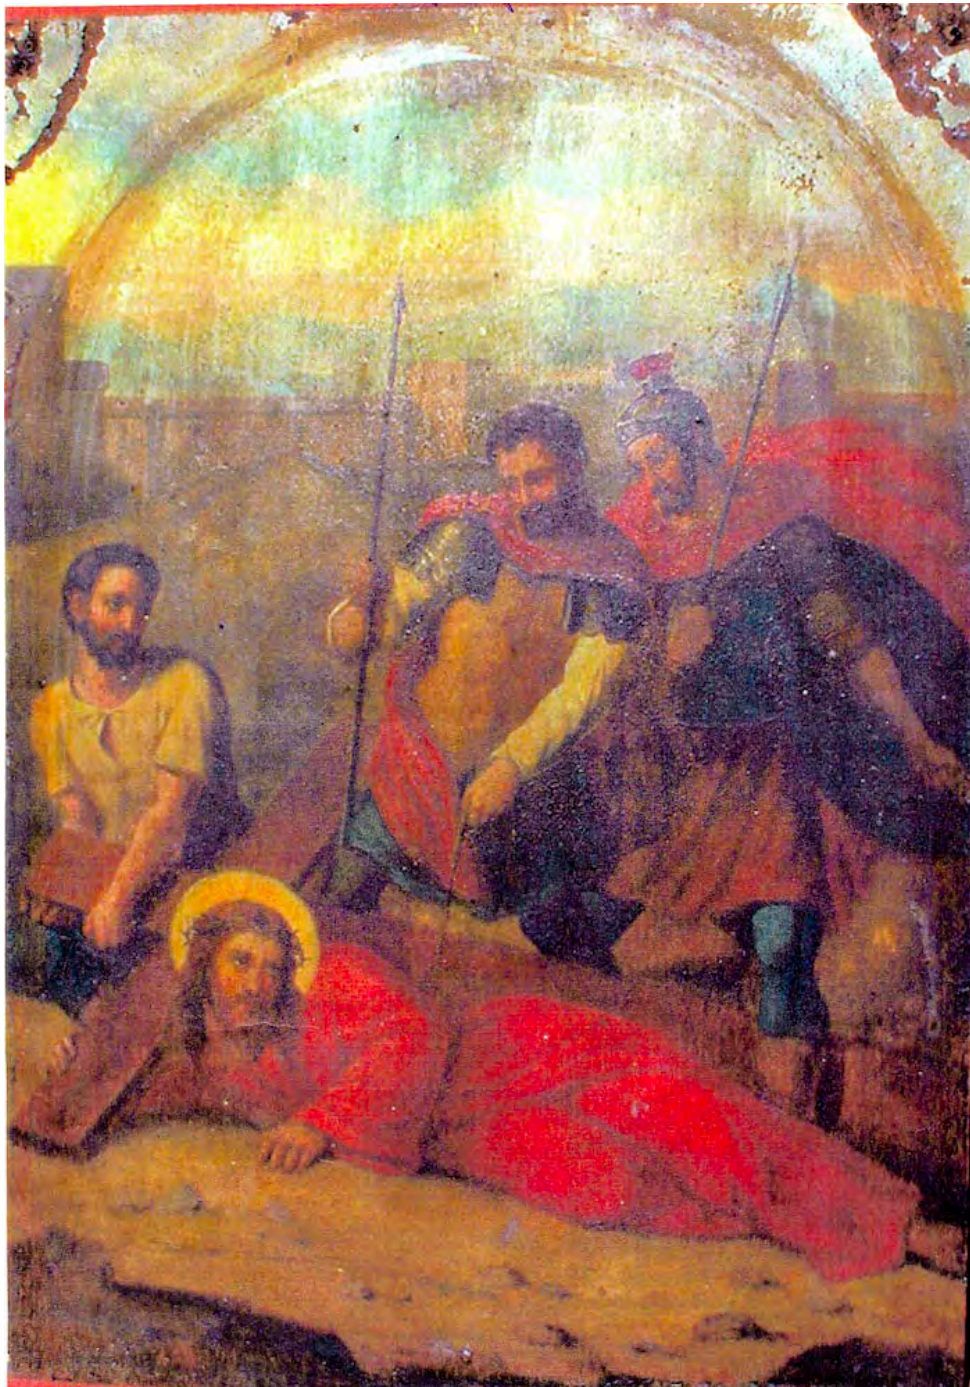
Station No:VII - Jesus falls the second time

Both top corners show severe rusting on front surface. Rear reasonably intact.

Varnish badly discoloured, streaked, and opaque. Major paint losses at both top corners. Areas of pitting evident elsewhere, with some degradation of paint surface in darker areas.

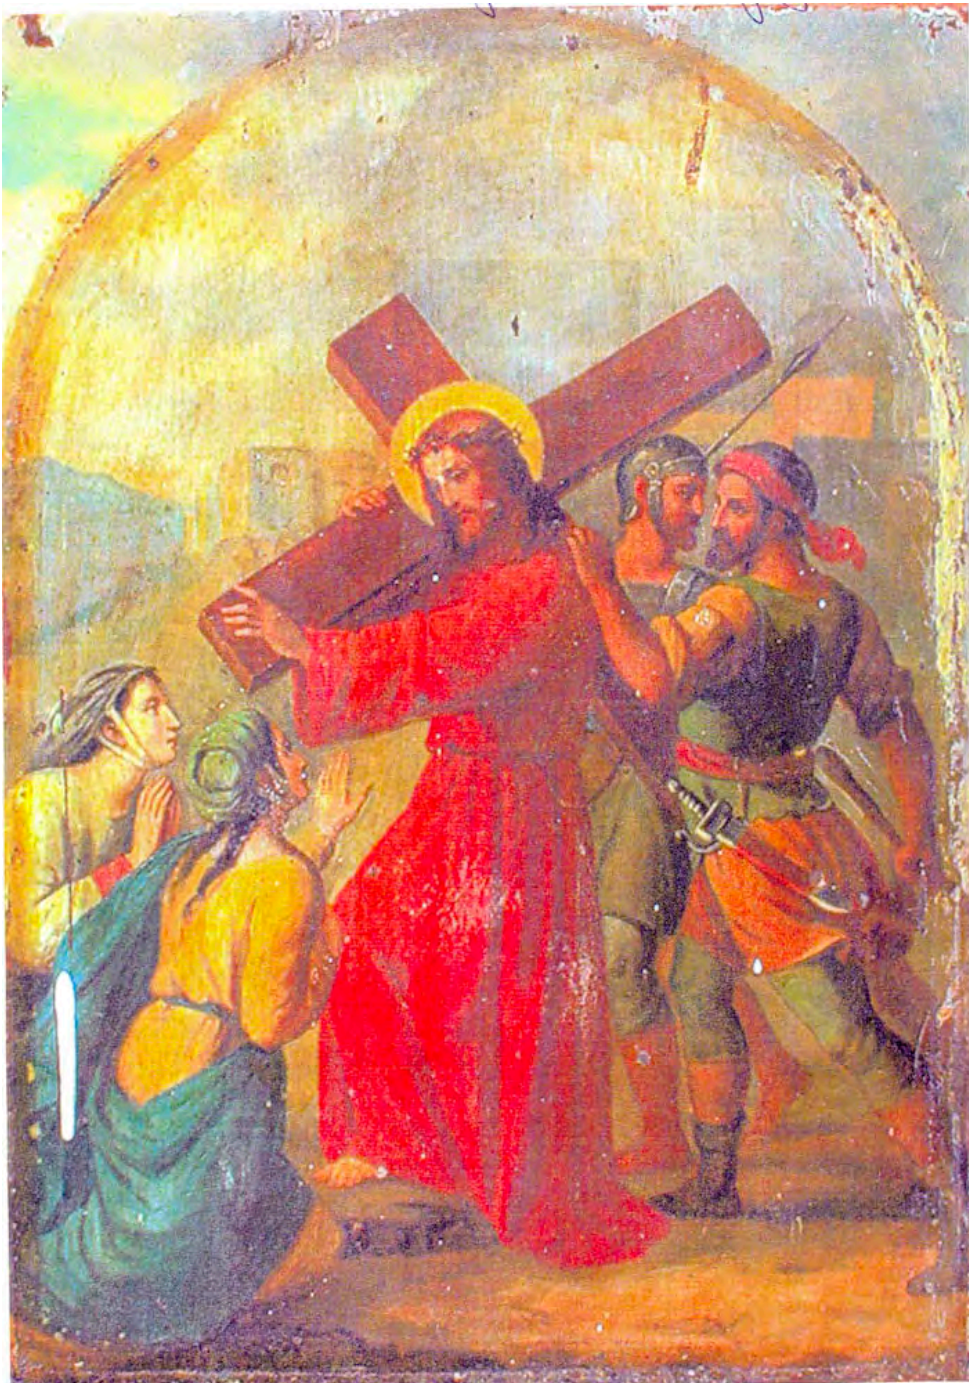
Station No:VIII - Jesus meets the women

Reasonably good condition, with damage confined primarily to top edge.

Varnish discoloured and streaked. General pitting of surface, with significant losses towards top right and along the right hand edge where the painting has rested on the frame. Some chipping of paint surface along top edge.

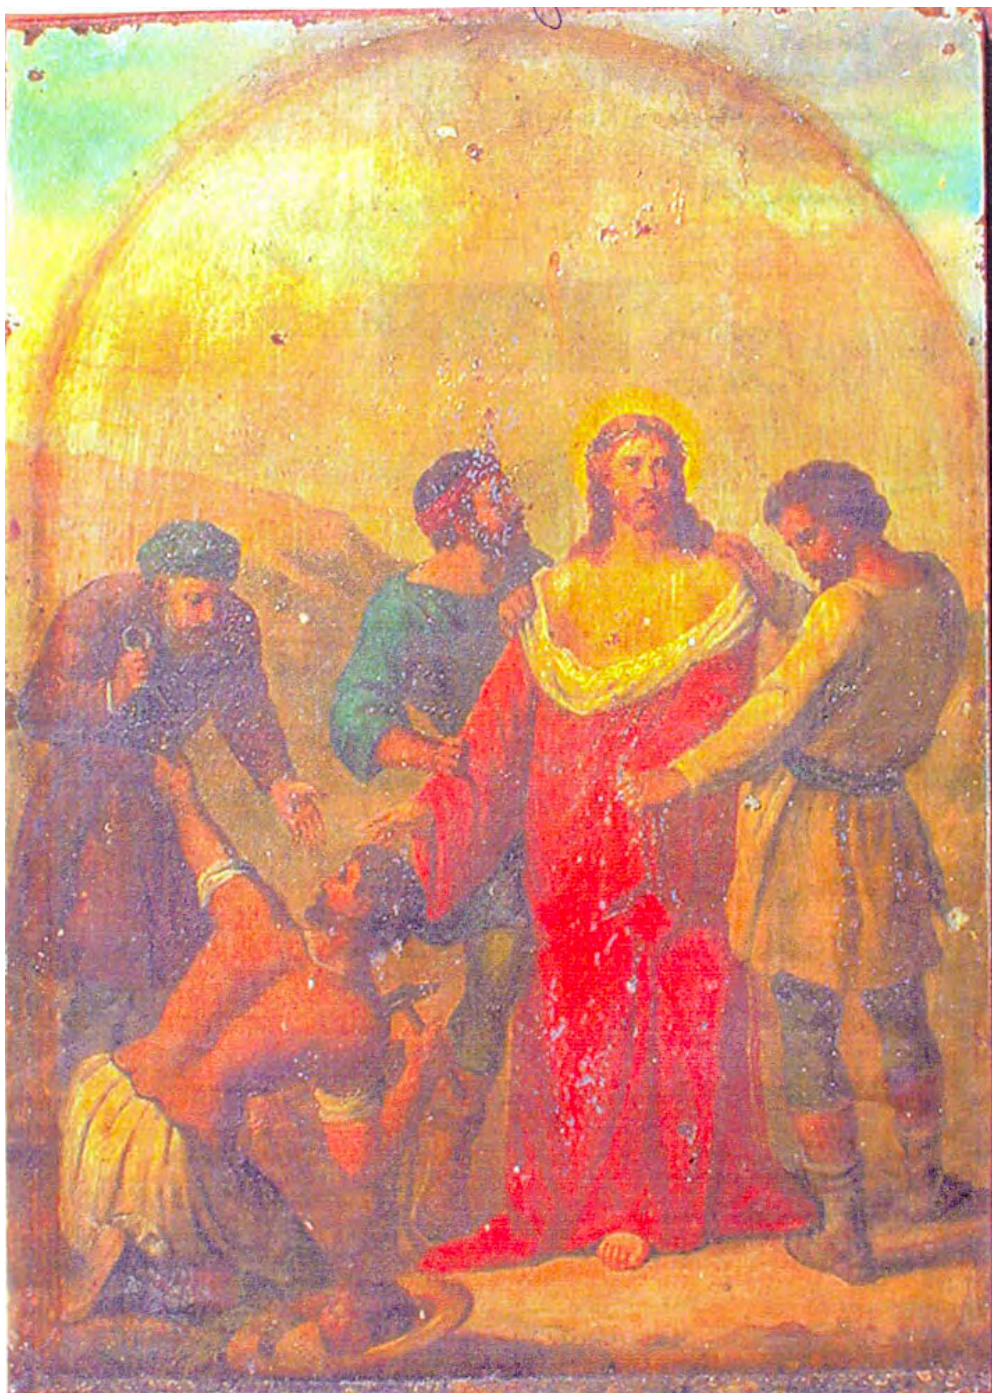
Station No:X - Jesus is stripped of His garments

Overall good condition, but with damage to top edge.

Very discoloured varnish. Streaked and becoming opaque, Significant pitting and paint losses on robe of Christ and over the face of the man on His right. Chipping along top edge. Paint loss along bottom edge.

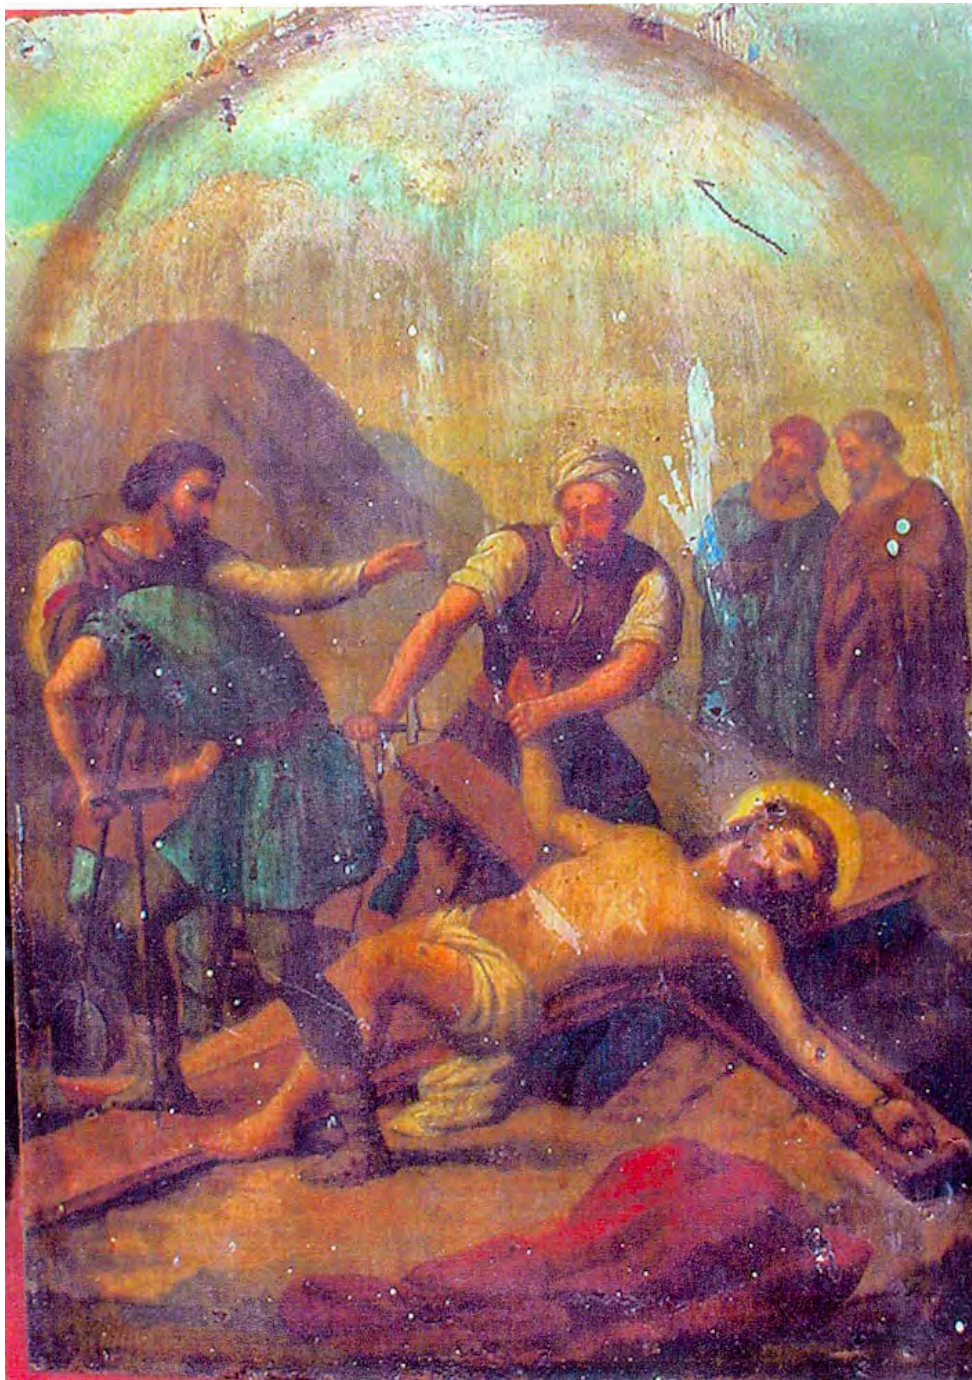
Station No:XI - Jesus is nailed to the cross

Overall good condition with little evident corrosion apart from bottom edge.

Discoloured and streaked varnish. Significant paint losses over the face of Christ, and what appears to be a large scratch some 3 cm long almost through to the steel.

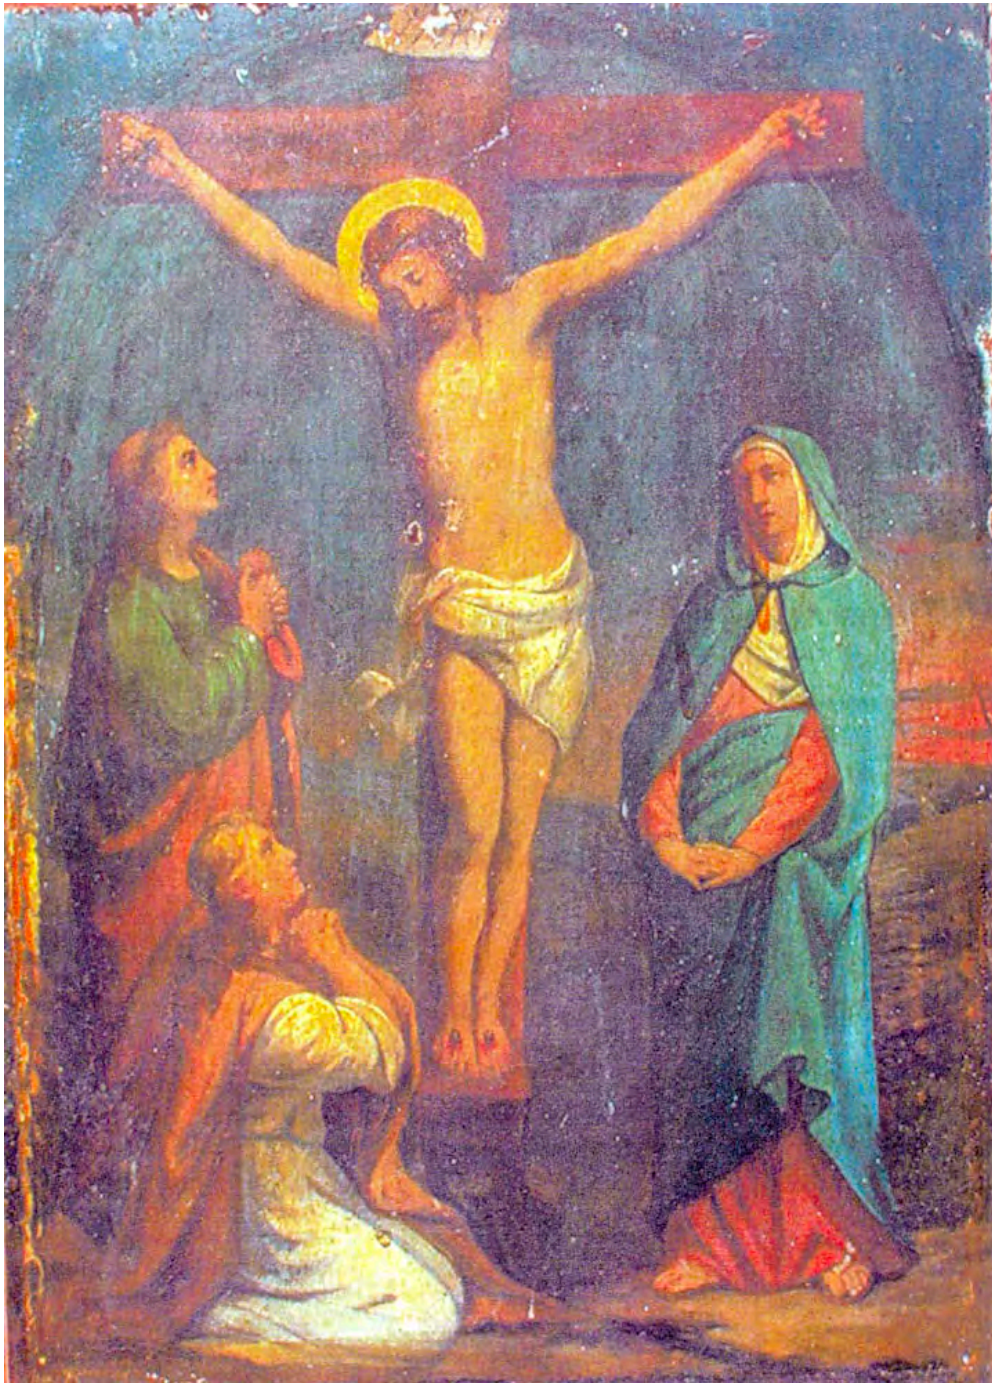
Station No:XII - Jesus dies

Corrosion damage to all edges.

Badly streaked and discoloured varnish. Large chip near centre. Significant damage along left hand edge and along top edge to the left.

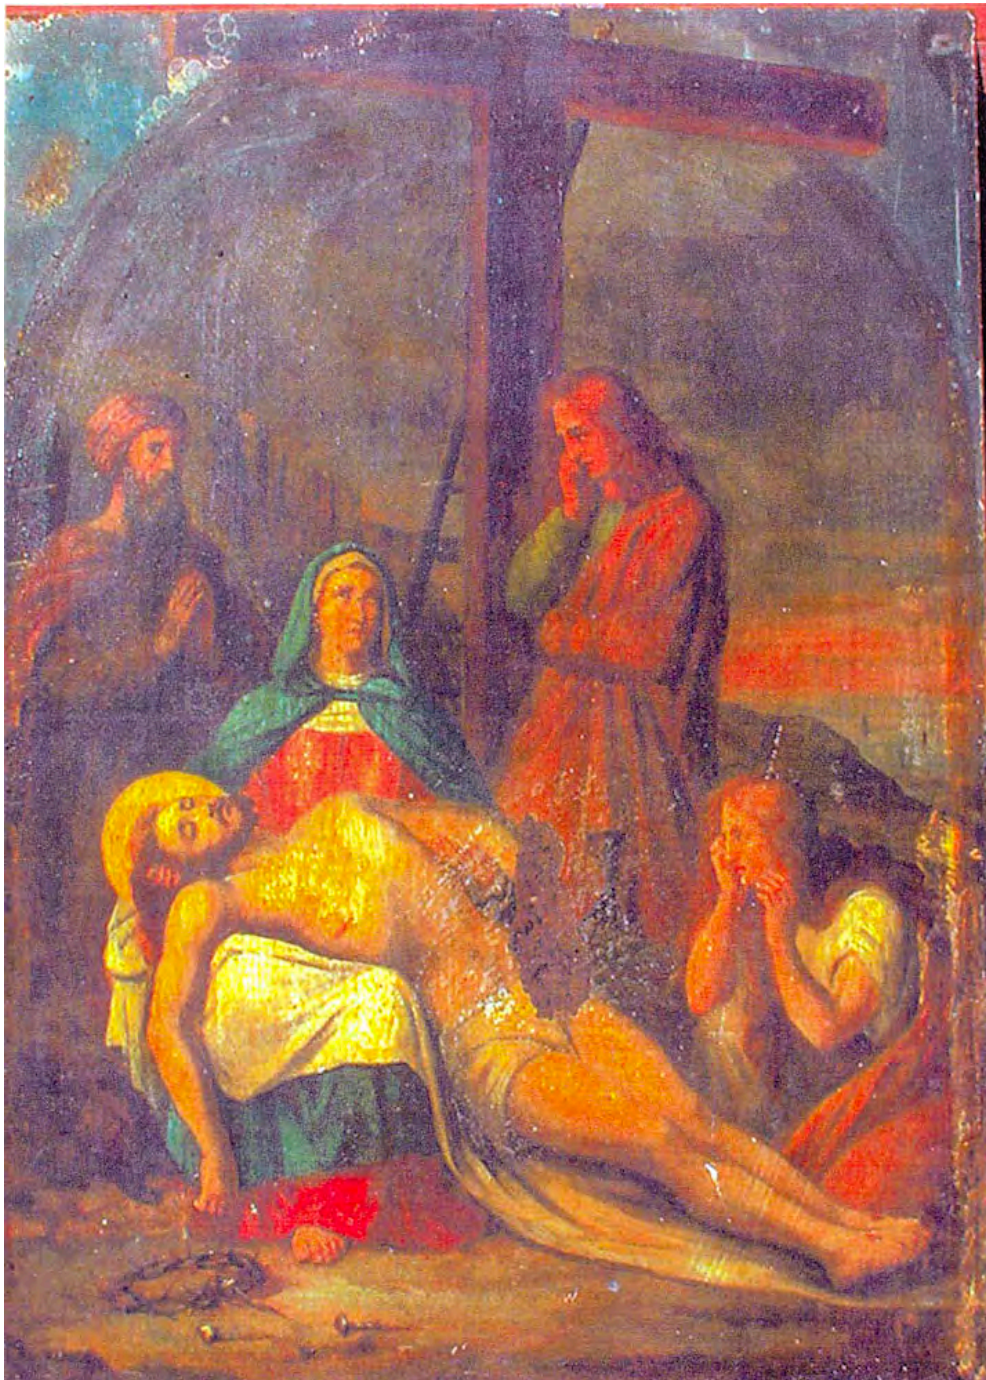
Station No:XIII - Jesus is taken down from the cross

General good condition, with minor corrosion damage confined to the edges.

Very discoloured varnish. Major paint loss near centre with what appear to be marks of abrasion. Further damage and bubbling of paint surface at top left. Pitting over the rest of the surface.

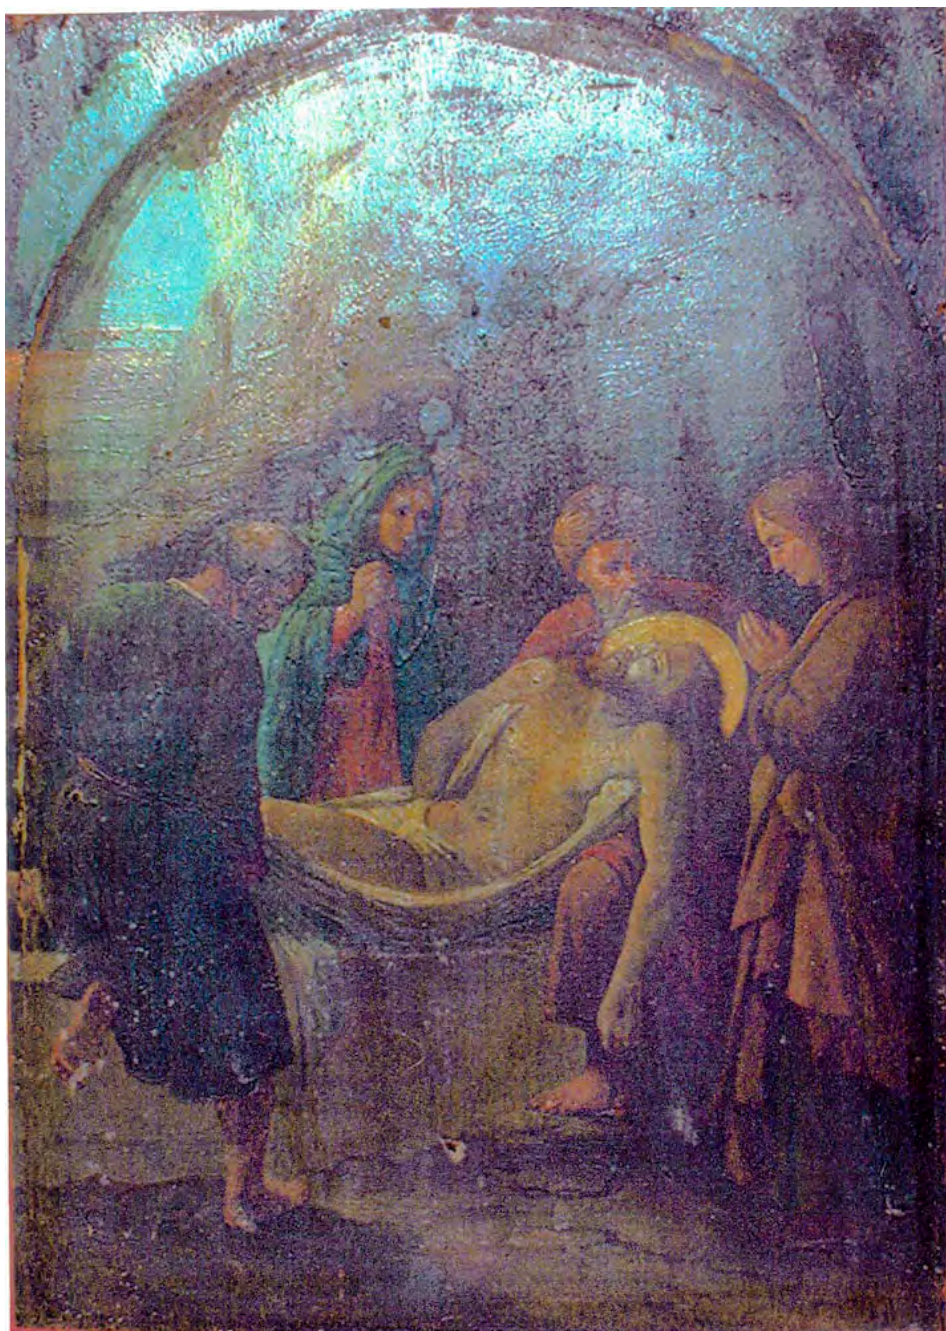
Station No:XIV Jesus is laid in the tomb

Pitting over much of the rear surface.

Varnish very discoloured. Cracks and chipping evident on surface with substantial paint loss at the top left corner. General pitting of surface.
